The Kona Earthquake of August 21, 1951, and Its Aftershocks¹

GORDON A. MACDONALD and CHESTER K. WENTWORTH²

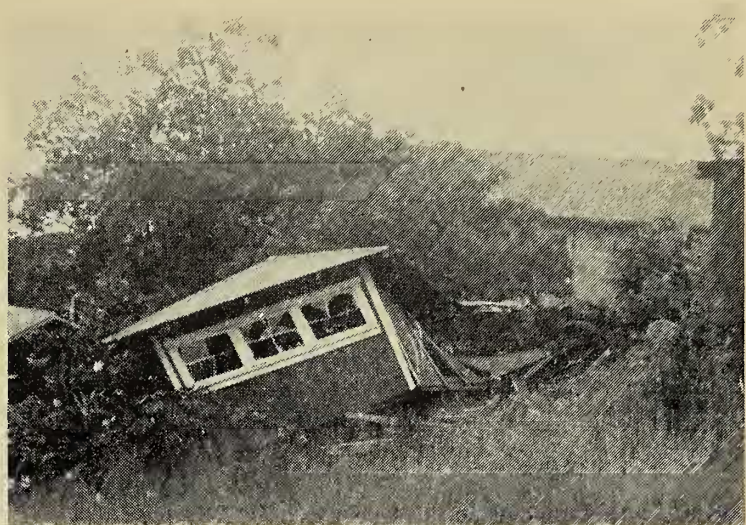
At Kaimalino, 0.3 mile south of Kealia (Fig. 1), a shop building collapsed. This building was placed on timber supports level with the highway in front but 6 feet above ground level in back, without adequate cross bracing.

FIG. 4. Overthrown shop building at Kaimalino, from the south.

Failure of the underpinning allowed the building to tilt backward and slump to the ground (Fig. 4). A similar situation was found at Keokea, 1.2 miles north of Kealia, where a service station building slumped downhill away from the highway and partly collapsed.

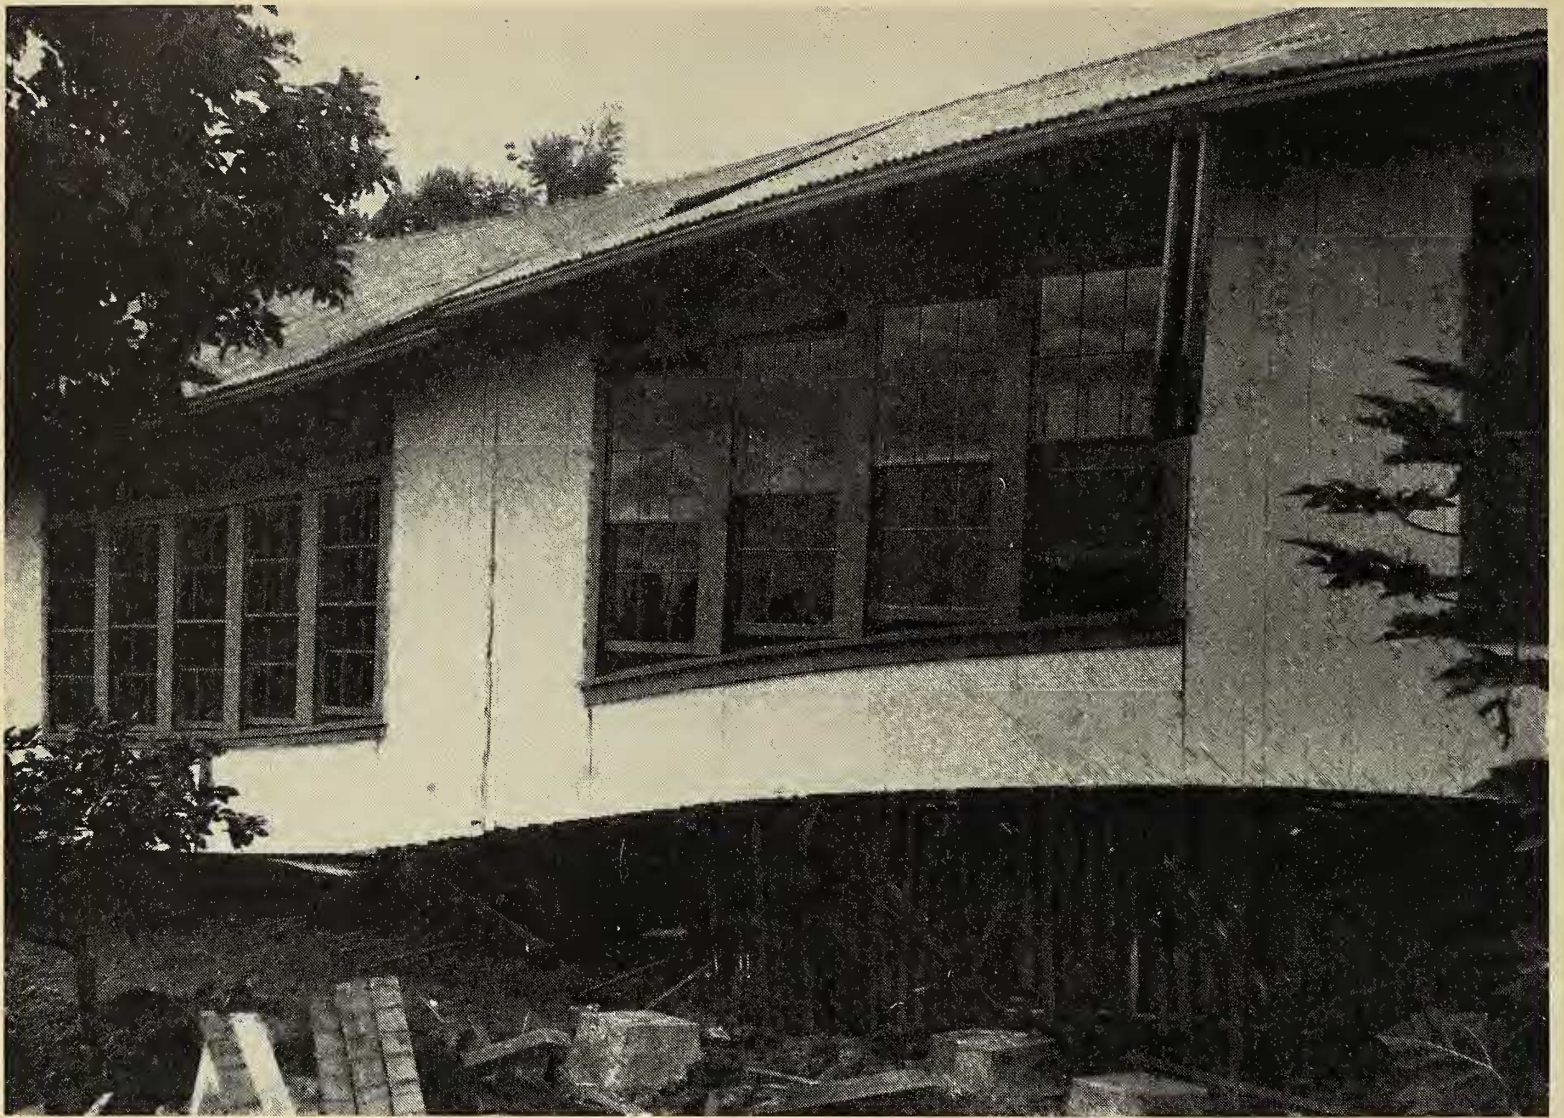
FIG. 5. Central portion of Honaunau School, from the southwest. All but the south end of this building was let down and moved westward owing to inadequate bracing of the underpinning in an east-west direction transverse to the longer dimension of the building.

structure, and the swaying of the structure caused the underpinning to fail in part and to allow the building to slump downhill onto the ground (Fig. 5). The building is considered a total loss.

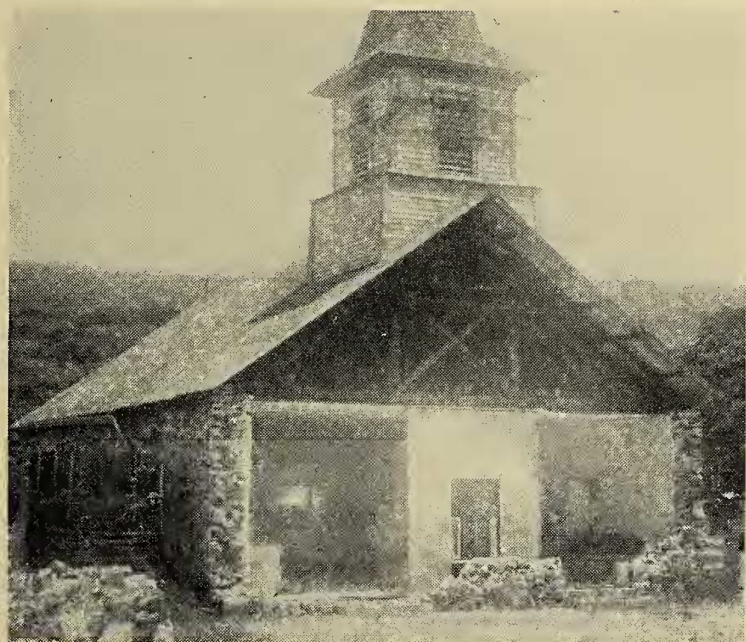
The Protestant church at Hookena Beach was badly damaged. The building consisted of masonry walls and a sheet-iron roof, supported on heavy handhewn beams which in turn were supported by east-west beams resting in niches on the upper edge of the front and back walls. During the earthquake nearly the whole front (west) wall was thrown out, some debris being as much as 25 feet from

FIG. 6. West end of Pukaana Church at Hookena Beach showing complete demolition of masonry wall of this 100-year-old structure. Much of the debris was cleared away soon after the earthquake. No nearly comparable damage to this building is known to have taken place during the century since it was built.

the building (Fig. 6). The other walls were not appreciably damaged, even the interior plaster being almost uncracked. It appears possible that during the quake the roof may have tended to move as a separate unit from the rest of the structure and, by its tendency to lag behind during the initial violent eastward movement of the ground, may have pushed out the front wall.

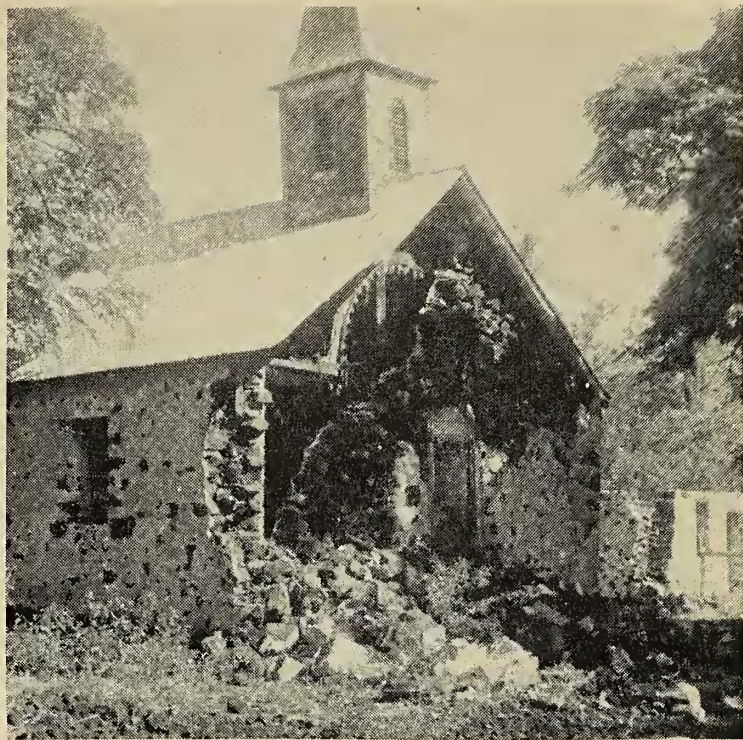
FIG. 7. Catholic Church 0.6 mile north of Hookena Beach, from the northwest. The east end of this church was similarly thrown down and outward, to the east. The near corner and the corresponding corner of the small building, already without a roof, suggest displacement most markedly to the northwest, in the general direction of the epicenter.

The Catholic church 0.6 mile north of Hookena Beach was very heavily damaged. The upper portions of both the east and west walls were thrown down (Fig. 7), and the interior plaster on all walls was badly cracked. However, the walls were built merely of loose stones laid together without mortar between them except close to the faces, where the interior and exterior plaster had penetrated a short distance. Considering the type of

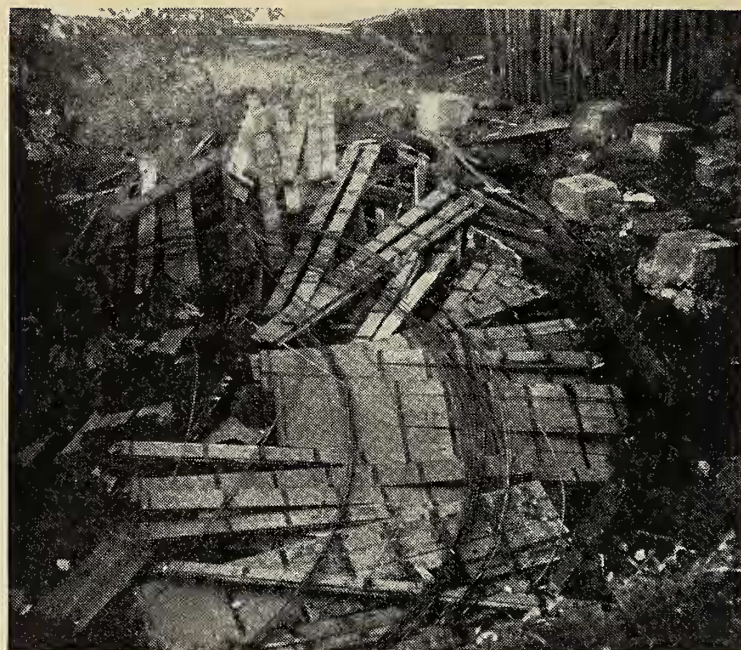
FIG. 8. Demolished tank west of the south end of Honaunau School, footings on which the tank formerly stood, and part of the school building, from the southwest.

building, to which it was connected by a rigid wooden down-spout. However, most of the damaged tanks appear to have failed because of their own behavior during the earthquake. The commonest features contributing to tank failure appear to have been poor footings and inadequate cross bracing of the underpinning.

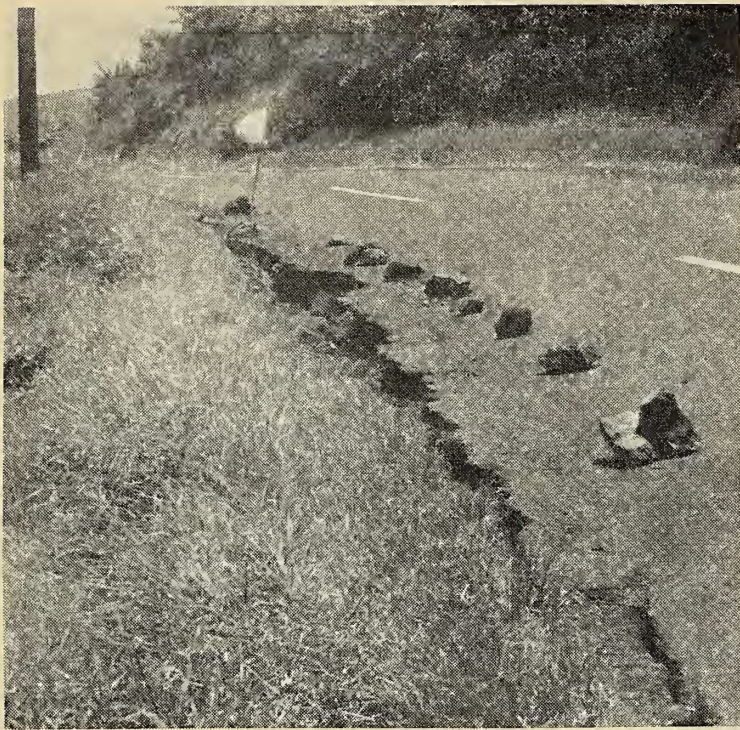
FIG. 9. Crack along roadside south of Kealakekua, from the south, showing separation of embankment from edge of pavement due to slumping.

slope face of the fill was dislodged, allowing the material of the road bed to settle, cracking the pavement. In other places the fill appears to have settled a little merely by compaction during the jostling by the earthquake, causing cracks in the pavement.

A common occurrence was the formation of a crack parallel to the edge of the pavement on its downslope side, either within the pavement a few inches from its edge or between it and the shoulder (Fig. 9). Some of these were as much as 75 feet long and 8 inches wide. This appears to have resulted from a downslope lurching of the shoulder, moving as a separate unit from the portion of the fill beneath the pavement. The independence of movement of the shoulder and pavement was interestingly shown along the highway about 2 miles southeast of Captain Cook, where soil and sod on the shoulder were overthrust as much as an inch onto the pavement.

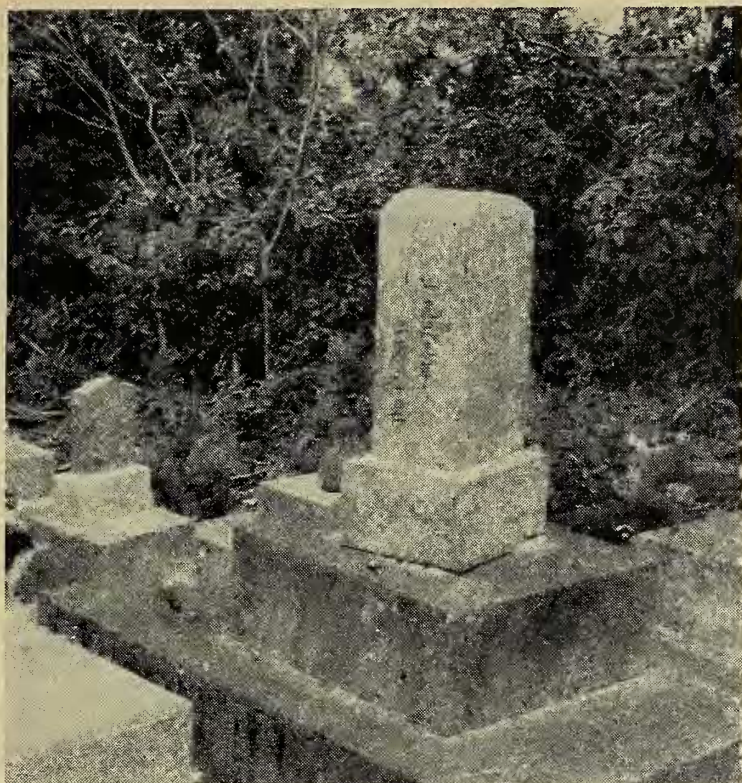
FIG. 10. Gravestone rotated counterclockwise, in Daifukuji cemetery, Kainaliu, looking approximately northwest.

north of Napoopoo, of an estimated total of 150 grave markers, 6 toppled west, 7 north, 2 east, and none south. Six had been shifted north, 16 were twisted counterclockwise, and 2 clockwise; 8 grave caps were broken (Fig. 10). It was reported that many more had been disturbed but had been restored.

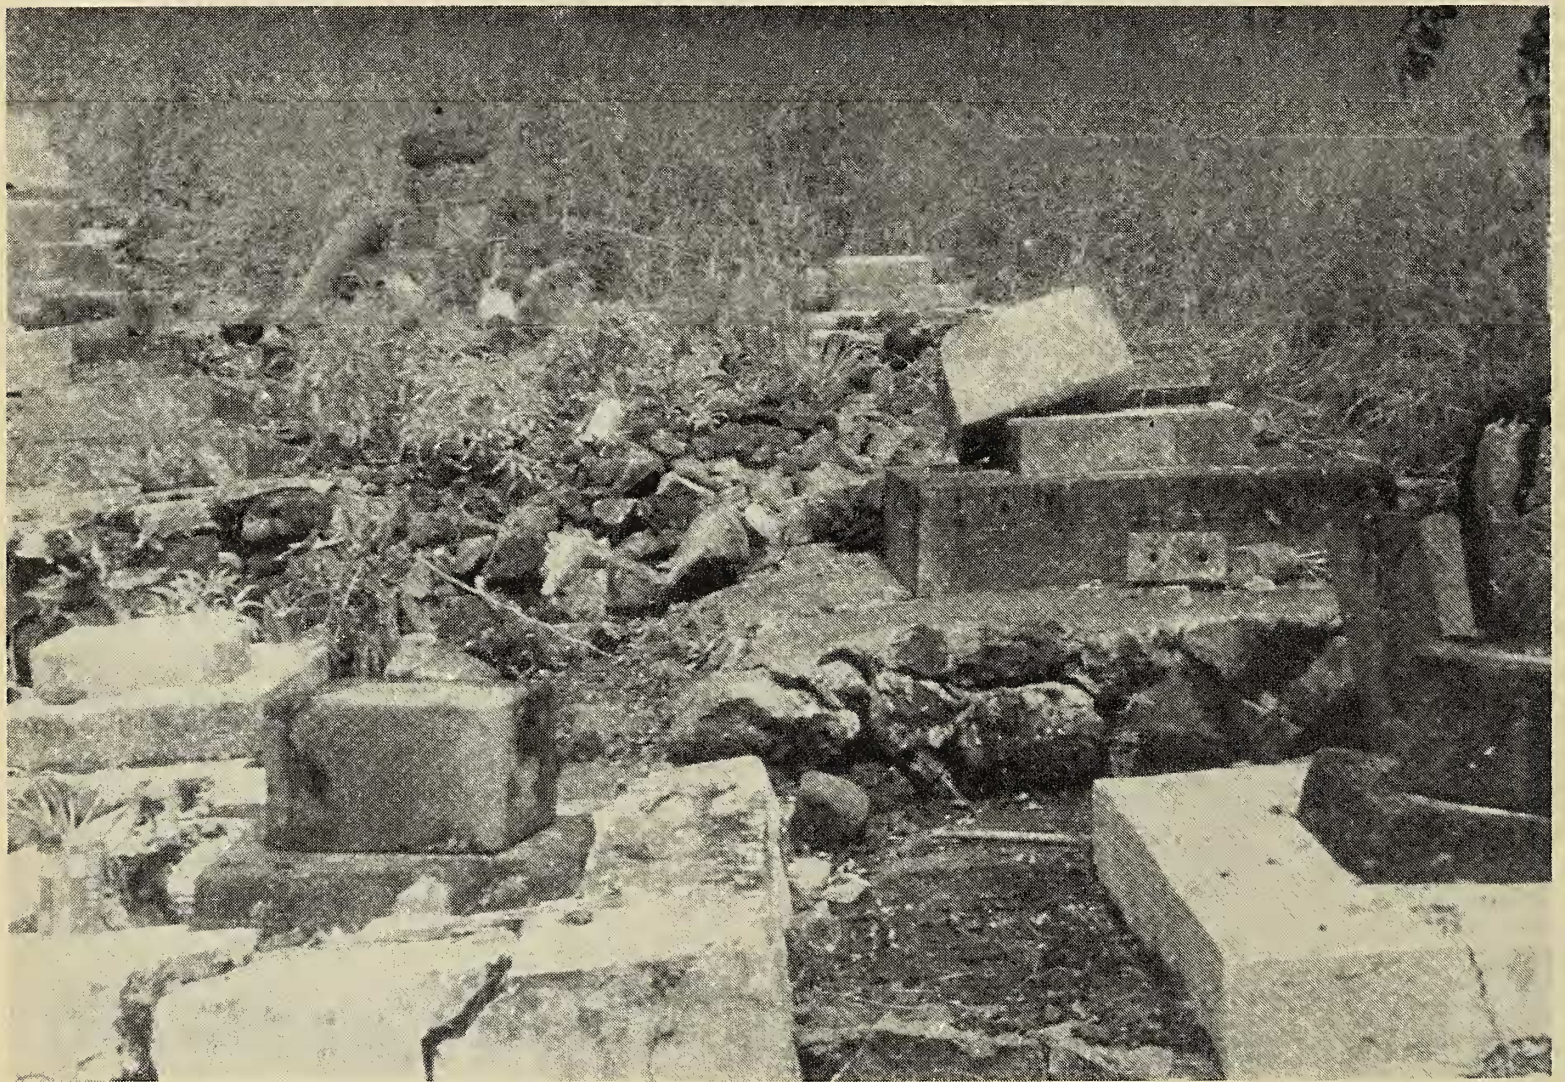
The most complete derangement of gravestones was found in the Kalahiki Japanese cemetery, a small hillside cemetery 3.8 miles south of Kealia, where only 2 of 30 markers were found in position 5 days after the earthquake (Fig. 11). The dislodgement was chiefly to the southwest and, to a lesser extent, to the northeast. Ten were shifted to the north without being thrown down. Seven, including some of these 10, were rotated clockwise and one counterclockwise. Here, on loose, steeply sloping ground, a large proportion of the grave caps were broken, owing to poor design and to construction on the newly heaped grave mound. This cemetery is about 11 miles south of the probable epicenter. South of this point no cemeteries with headstones susceptible to overturning or rotation were found.

FIG. 11. Broken bases, displaced base stones, and overturned headstones in Kalahiki Japanese cemetery, south of Kealia, looking southeast. Partly because of unstable hillside ground and partly because of proximity to the epicenter, damage in this cemetery was widespread and severe; scarcely a grave escaped marked derangement.
